Monthly Oversight Report 70 (FINAL)

ACS NPL Site

Griffith, Indiana

September 30, 2006 – November 3, 2006

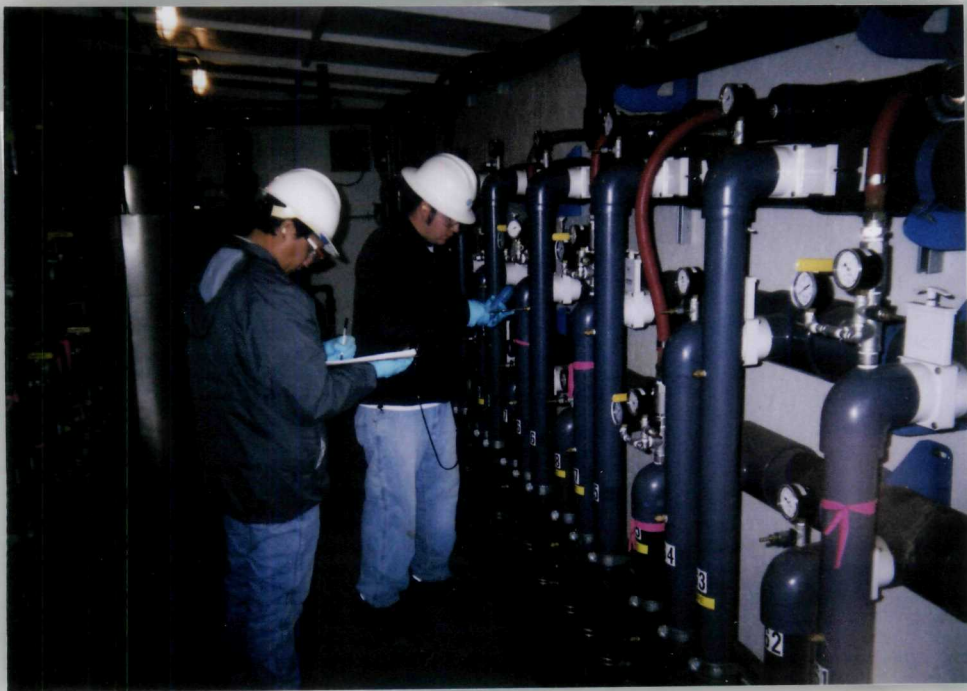
0927 Photo 9301 looking W into SBPA  
ISVE Blower shed at MWR crew  
taking measurements of  
ISVE system

Site: American Chemical Service, Inc.  
Proj. #: 44728 AES [46526 RAC]  
Roll: 93 Photo #1  
Date: 10-19-06 Time: 0927  
Photographer: Larry Campbell  
Description: Photo facing west into SBPA ISVE blower shed showing MWH crew taking measurements of ISVE system.

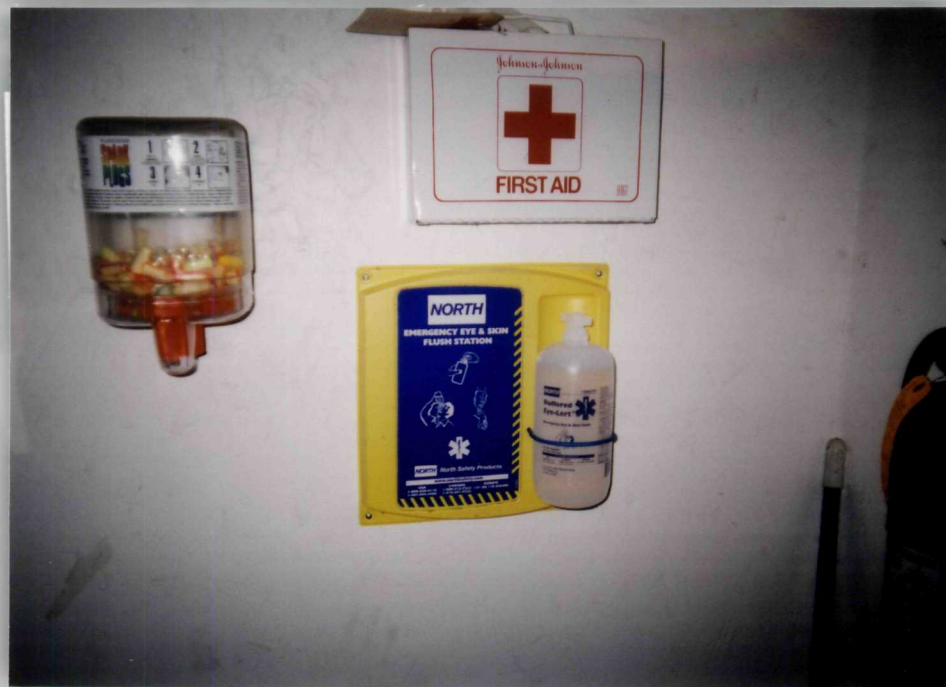
0933 Photo 93-02 looking N  
inside SBPA ISVE blower shed at  
new eye wash system

Site: American Chemical Service, Inc.  
Proj. #: 44728 AES [46526 RAC]  
Roll: 93 Photo #2  
Date: 10-19-06 Time: 0933  
Photographer: Larry Campbell  
Description: Photo facing north inside SBPA ISVE blower shed showing new eye wash station on wall of shed.

Eyewash stations for inside the blower sheds have been ordered. The eyewash stations are expected to arrive during the month of October and will be installed in both ISVE blower sheds.

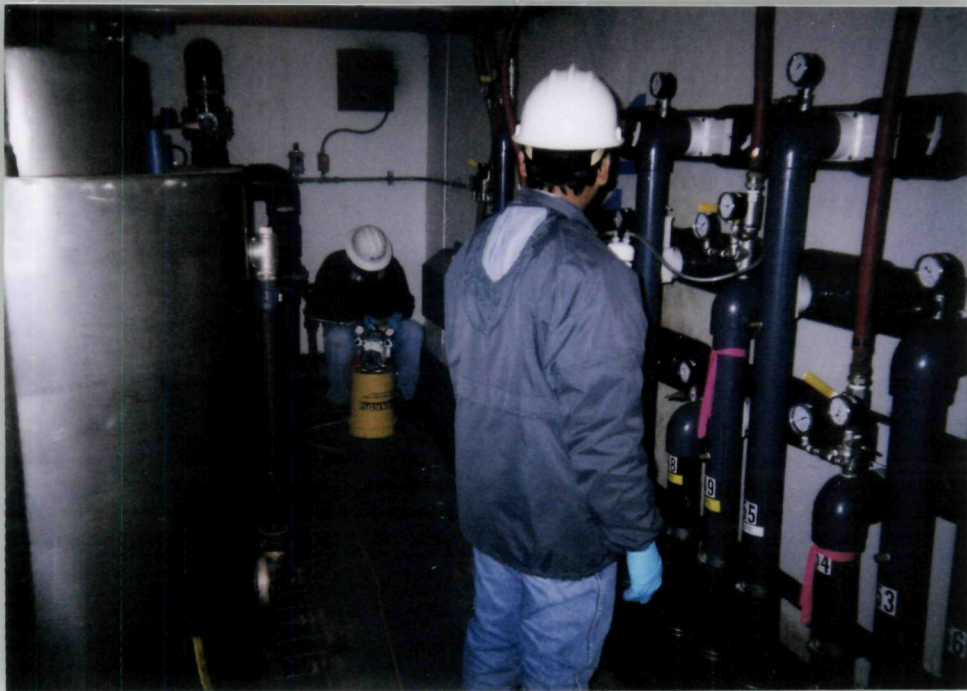
0956 Photo 93-05 looking N at  
MWH checking VOC levels in  
vacuum lines @ SBPA ISVE system

Site: American Chemical Service, Inc.  
Proj. #: 44728 AES [46526 RAC]  
Roll: 93 Photo #5  
Date: 10-19-06 Time: 0956  
Photographer: Larry Campbell  
Description: Photo facing north showing MWH personnel checking VOC levels in vacuum lines in SBPA ISVE system.

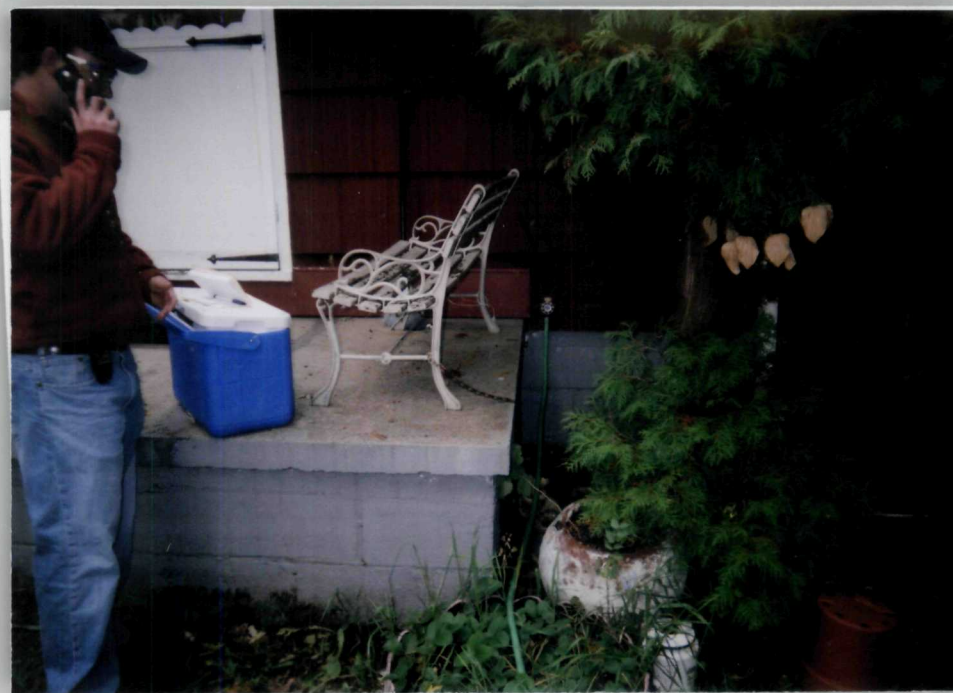
1205 Photo 93-06 looking N  
at house connected to water  
spigot at 1009 Redox Rd. Water

to house provided by well screened  
in upper aquifer, w/o any  
filters or softener

Site: American Chemical Service, Inc.  
Proj. #: 44728 AES [46526 RAC]  
Roll: 93 Photo #6  
Date: 10-19-06 Time: 1205  
Photographer: Larry Campbell  
Description: Photo facing north showing hose (green) connected to house water spigot at 1009 Reder Road. Water pumped from upper aquifer without any filters or softeners in the line.

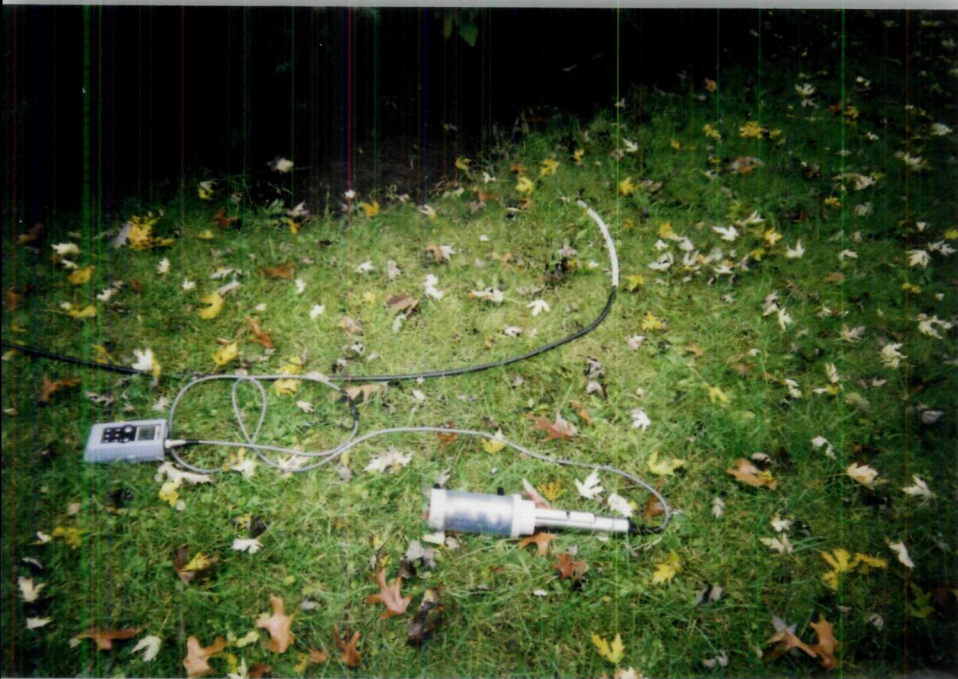
1207 Photo 93-07 looking E at  
house, Hoorah Cell and discharge  
of purge water to ground.

Site: American Chemical Service, Inc.  
 Proj. #: 44728 AES [46526 RAC]  
 Roll: 93 Photo #7  
 Date: 10-19-06 Time: 1207  
 Photographer: Larry Campbell  
 Description: Photo facing east showing green hose,  
 Horiba cell, and discharge of purge water to the ground.

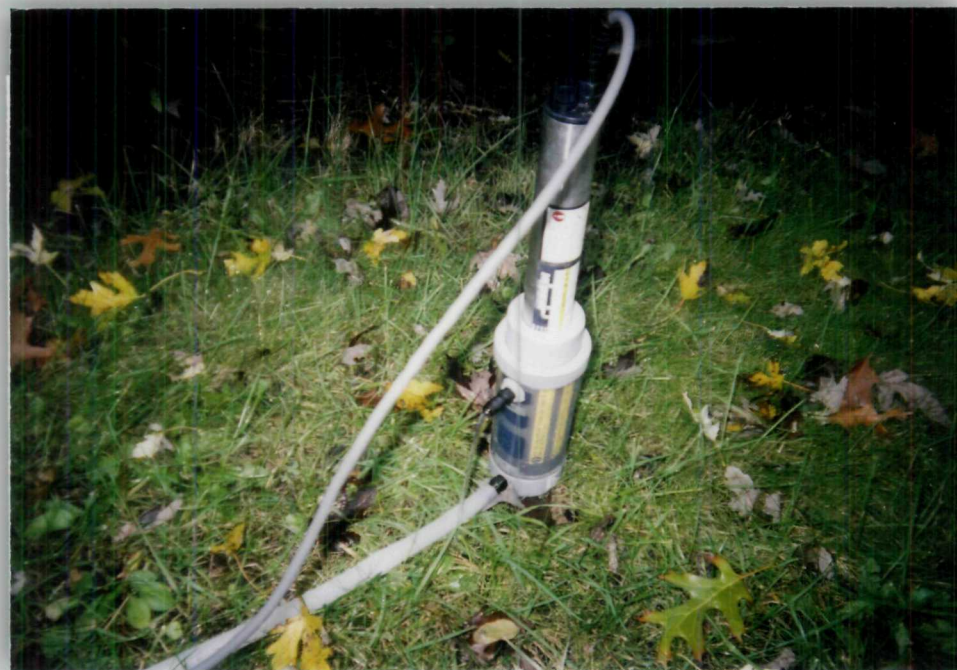
1209 Photo 93-08 looking N at  
discharge from Hoorah Cell

Site: American Chemical Service, Inc.  
 Proj. #: 44728 AES [46526 RAC]  
 Roll: 93 Photo #8  
 Date: 10-19-06 Time: 1209  
 Photographer: Larry Campbell  
 Description: Photo facing north showing discharge  
 from Horiba cell.

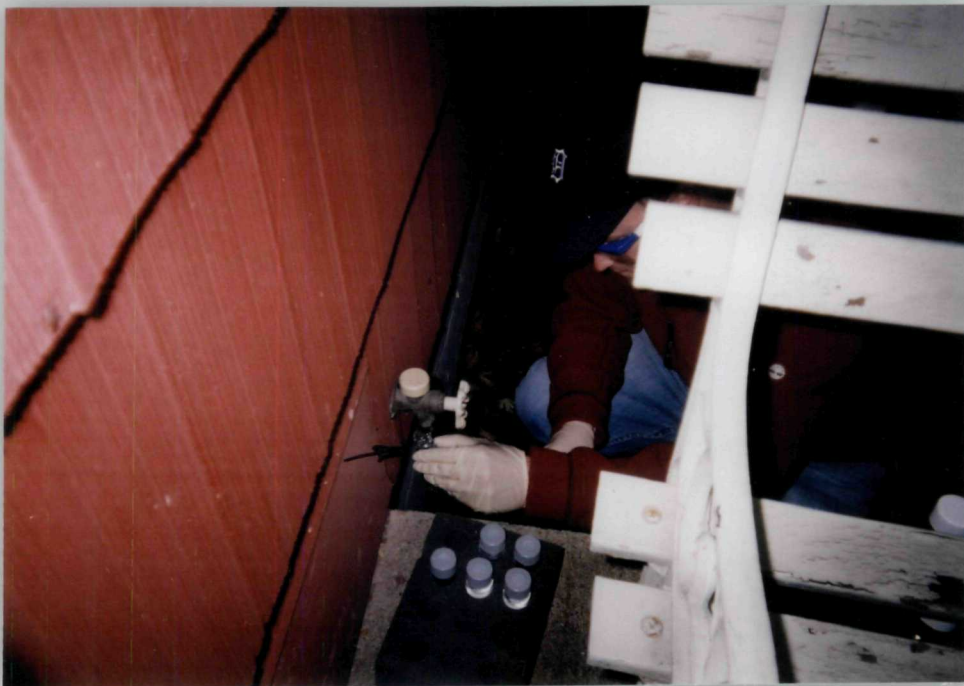
1231 Photo 93-09 looking down  
at Dave collecting VOC sample  
directly from spigot

Site: American Chemical Service, Inc.  
Proj. #: 44728 AES [46526 RAC]  
Roll: 93 Photo #9  
Date: 10-19-06 Time: 1231  
Photographer: Larry Campbell  
Description: Photo facing down showing Dave  
collecting VOC sample directly from spigot.

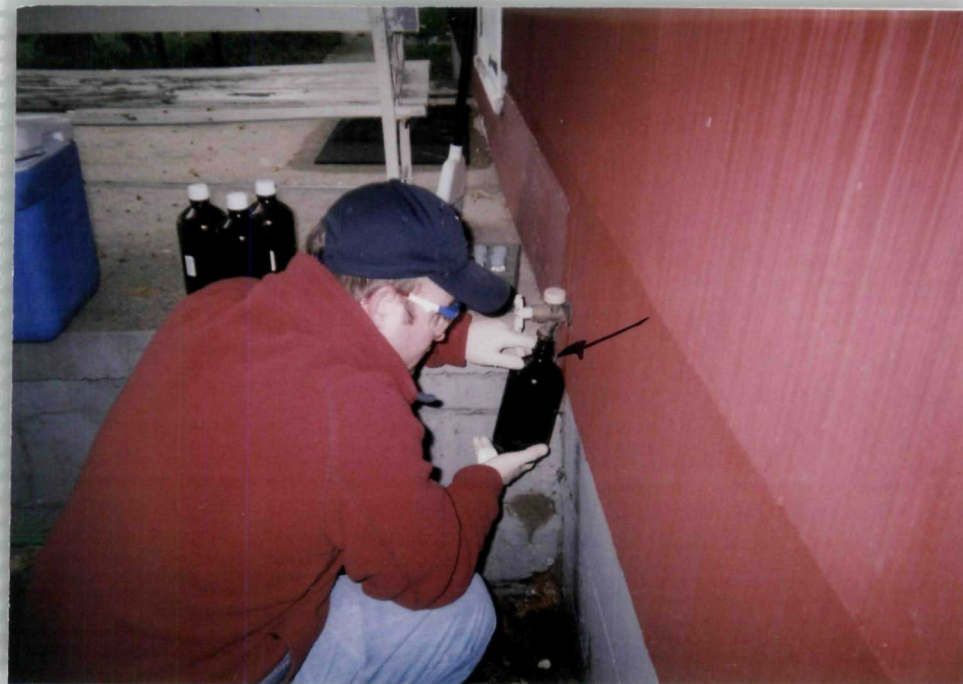
1233 Photo 93-10 looking W at  
Dave collecting IL sample from  
house spigot

Site: American Chemical Service, Inc.  
Proj. #: 44728 AES [46526 RAC]  
Roll: 93 Photo #10  
Date: 10-19-06 Time: 1233  
Photographer: Larry Campbell  
Description: Photo facing west showing Dave  
collecting 1 Liter sample from the house spigot.
